CENTRAL LIBRARY

Investigation Report

Central Library Fire
Los Angeles, California
April 29, 1986

Michael S. Isner

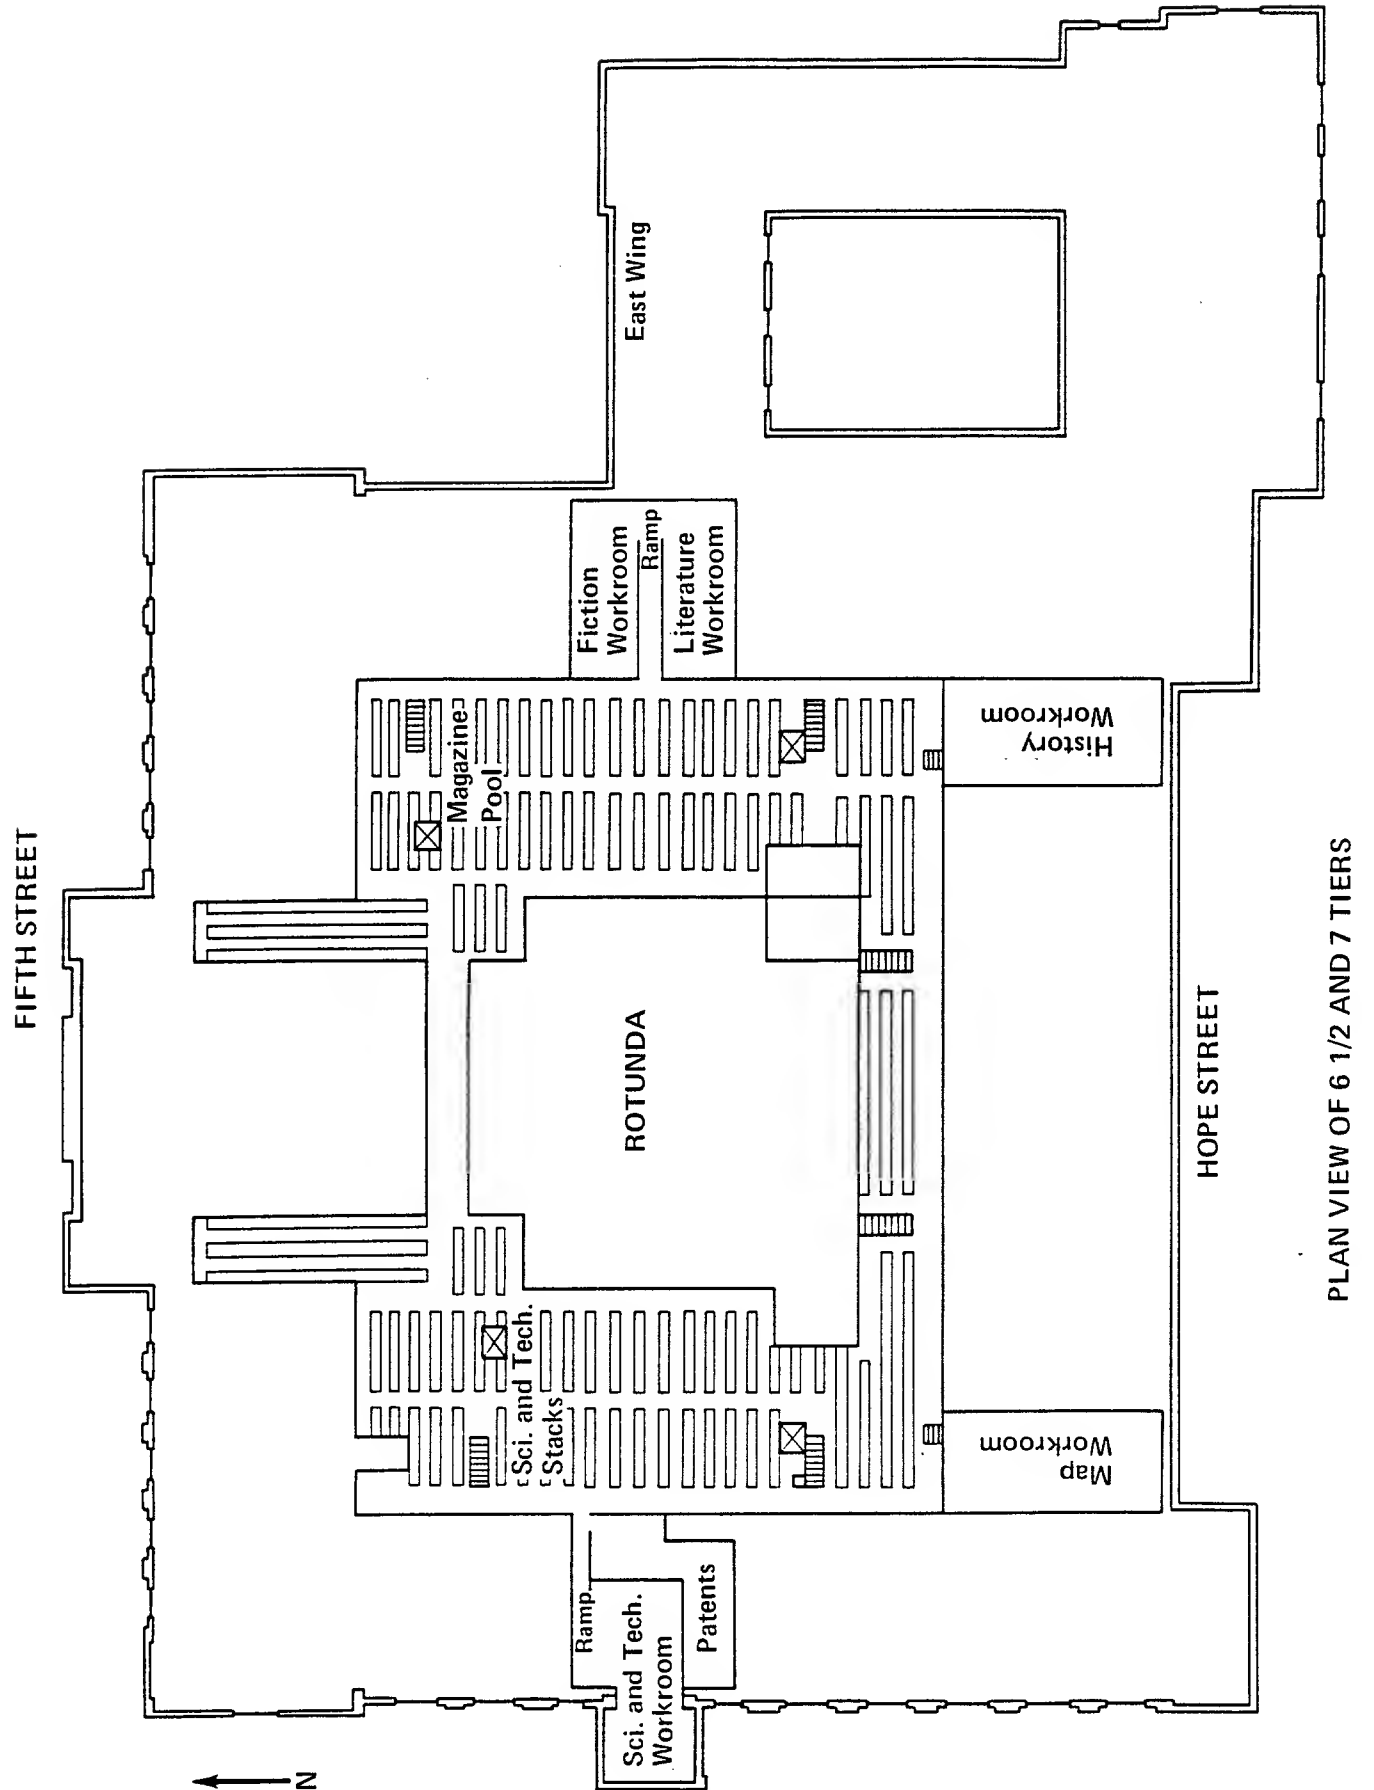
Figure 2

When the E-10 crew arrived on the third floor, they found light smoke in a corridor and heavy smoke in a room. This crew requested assistance (1114 hours) and deteriorating conditions eventually forced them from the area. The E-10 crew exited the third floor by a fire escape ladder at a window. The ladder allowed the crew to move to the roof of the east wing where they requested 1 1/2 hoses and other equipment. With this equipment, the fire fighters reentered the building at the Fiction and Literature Workroom (6 1/2 tier level) and went up a ramp to enter the 7th tier of the NE stack (see Figures 2 & 4).

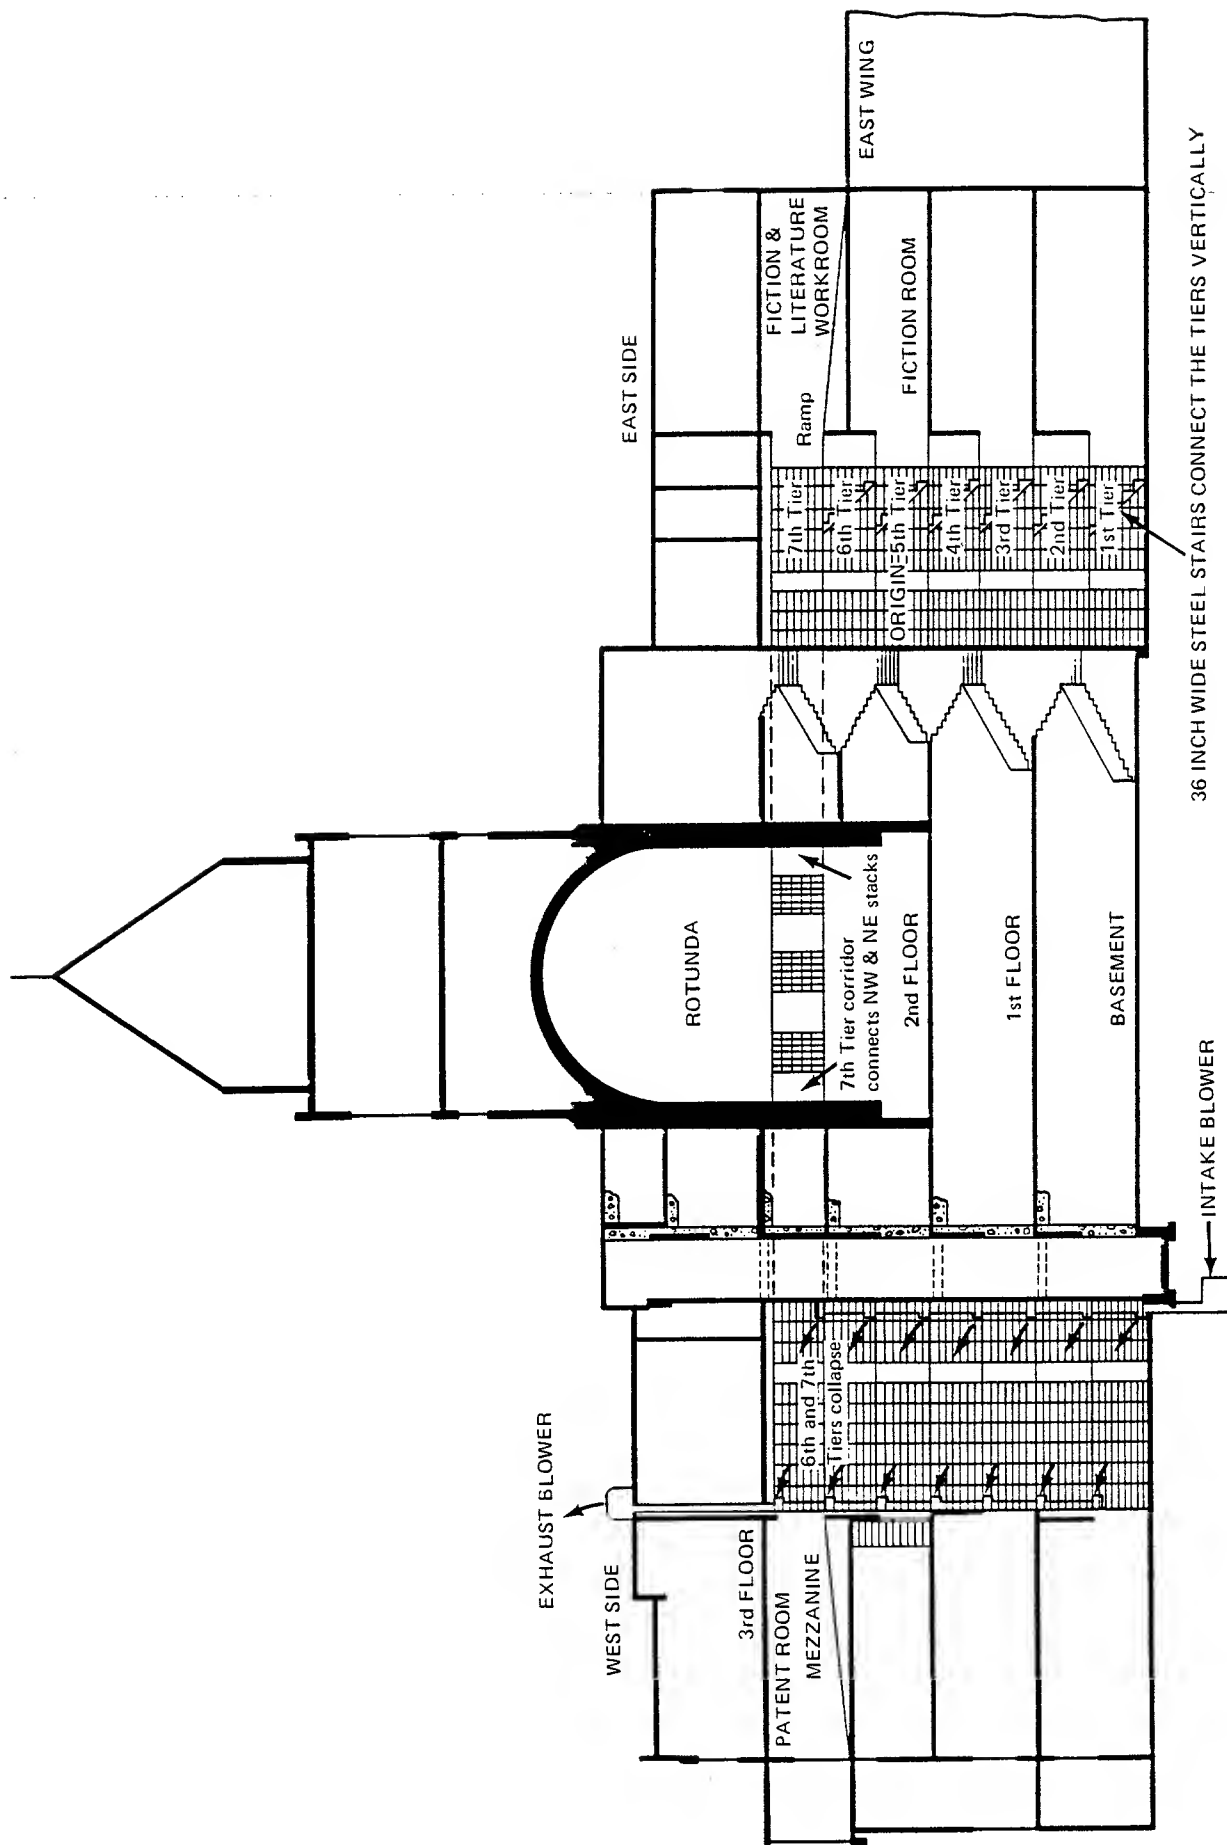
Figure 4

A mechanical air-handling system enhances the natural air circulation within the stack levels. Makeup air is drawn in at the base of the stacks and is discharged at each tier level. A duct on the opposite side of the tiers collects air from the stack and then the air is discharged at roof level (see Figure 4). Openings between the bookshelves and walkways (opening #1, see Figure 3), between the backs of bookshelves (opening #2, see Figure 3), and around the entire perimeter of the stack area also contribute to air circulation within the book stacks. Apparently, circulating air would contribute to the heating of the stacks and would help preserve books and reduce mildew in the non-air-conditioned building.

Having identified the location of the detector activations from the main alarm panel, the E-3 crew entered the NE stack in the basement and climbed the 36-inch wide open stairs to the 5th tier where they left the stack to tie into a hose station located in a stairway leading to the second floor (see Figure 4). The crew reentered the stack at the 5th tier level, advanced their hose
